Consulting Engineers, P.C.

Structural Engineering  
Geotechnical Engineering  
Historic Preservation  
Construction Support

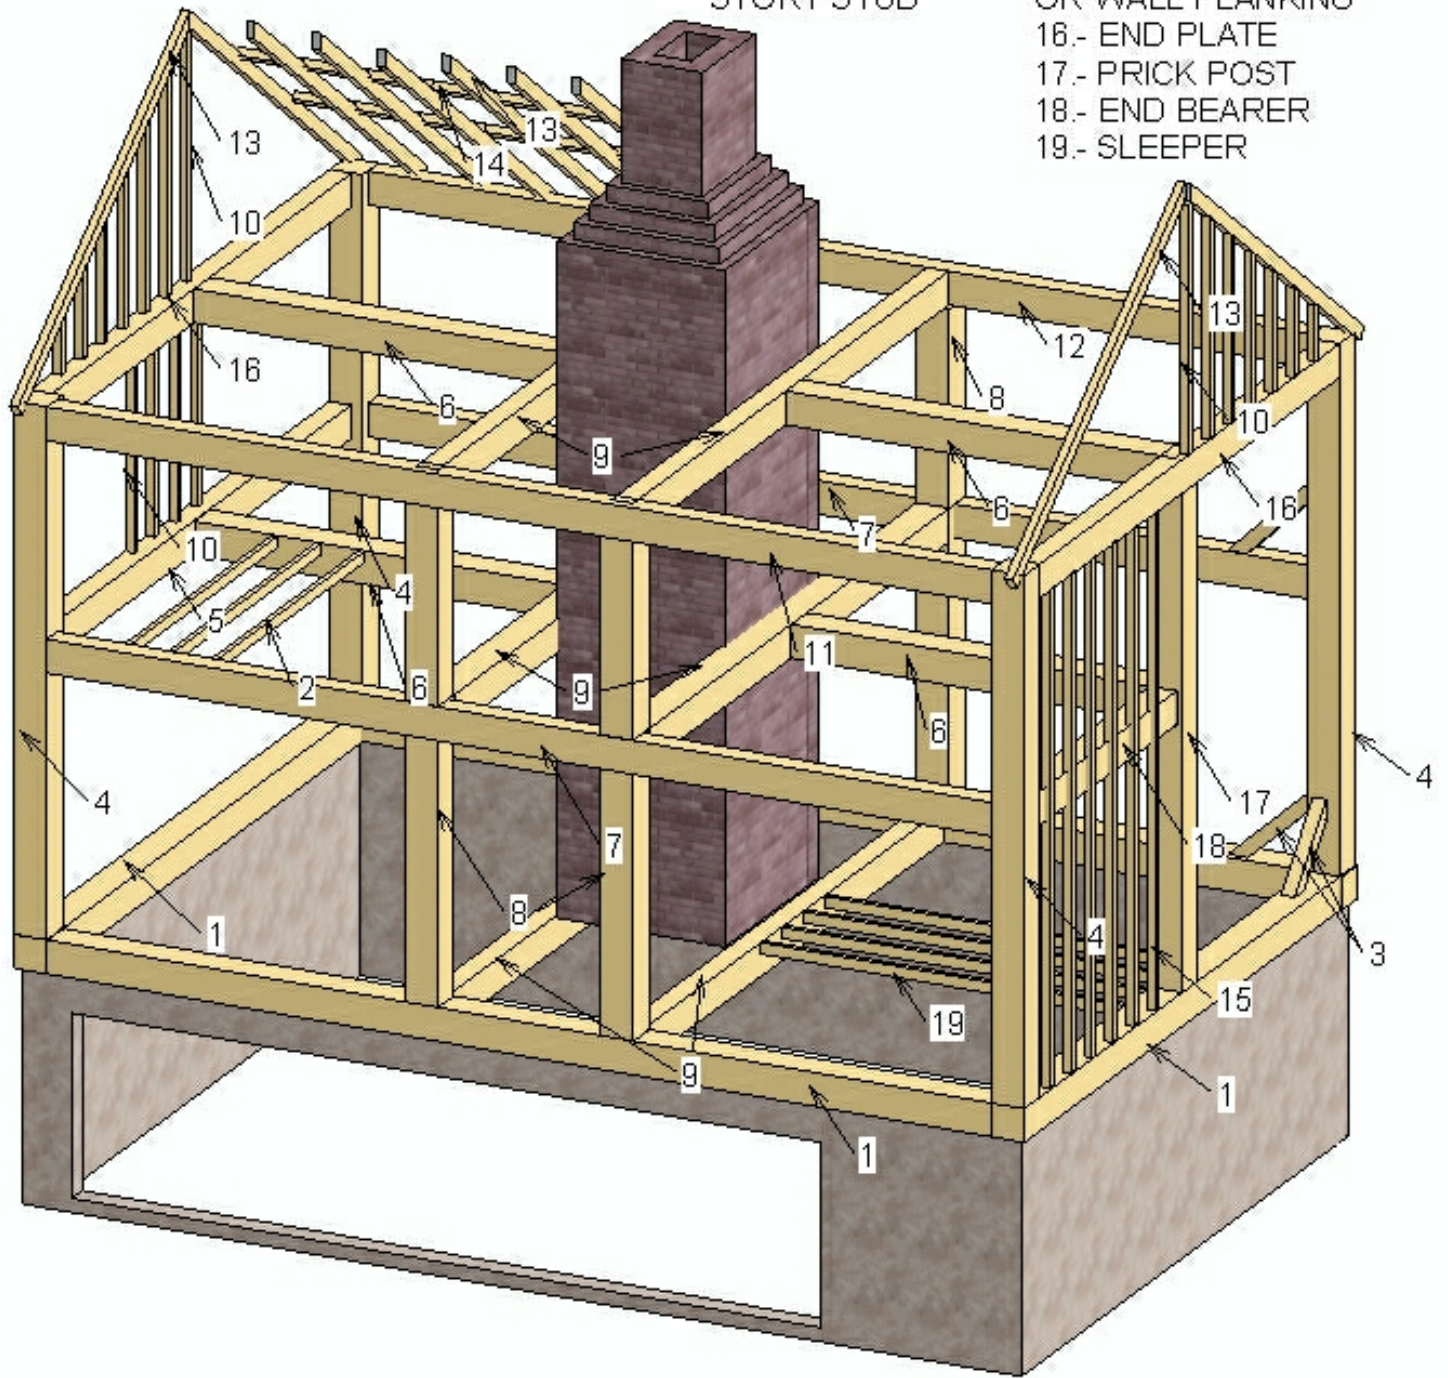
| | | 19.- SLEEPER |

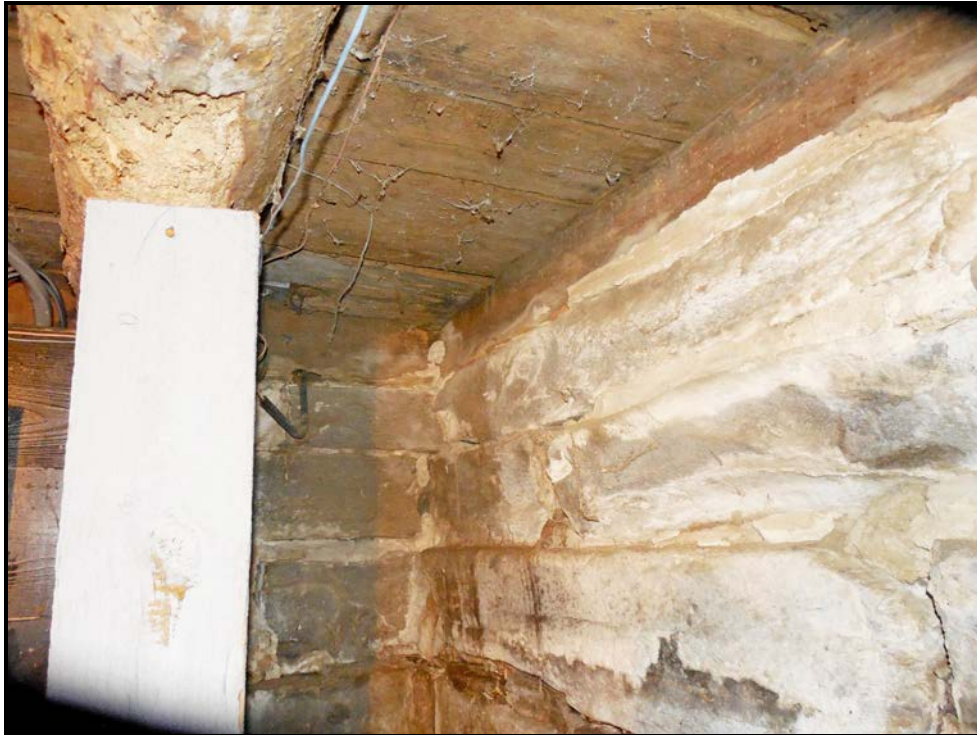
**Photo P01 – Timber sill with mortar seal trapping moisture in wood.**

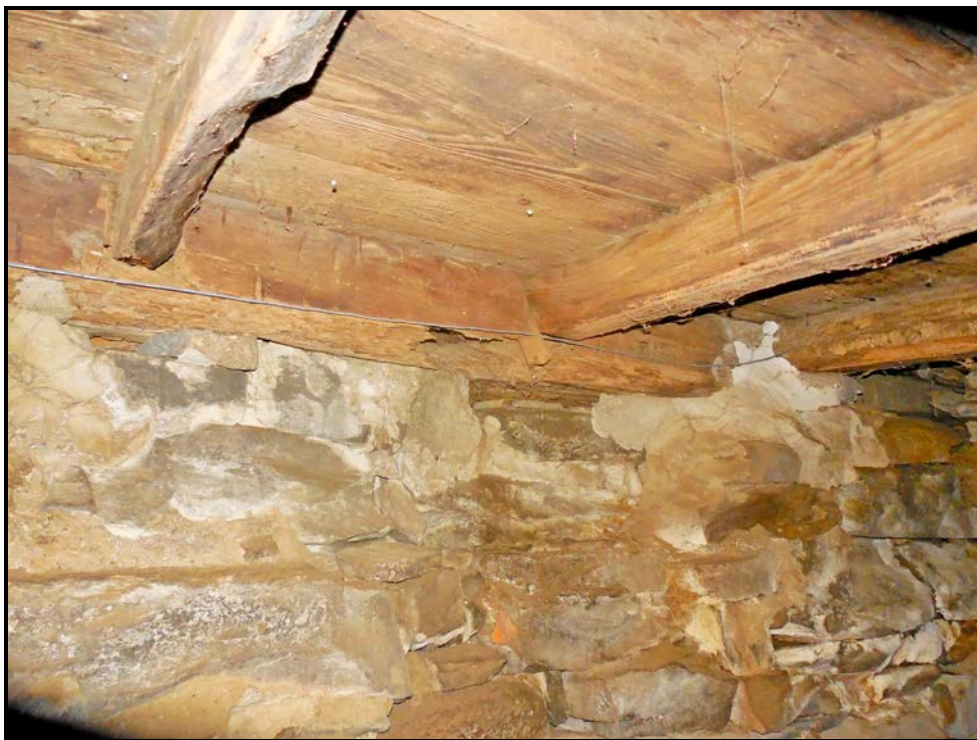
**Photo P02 – Front timber sill with dry rot and powder post beetle damage.**

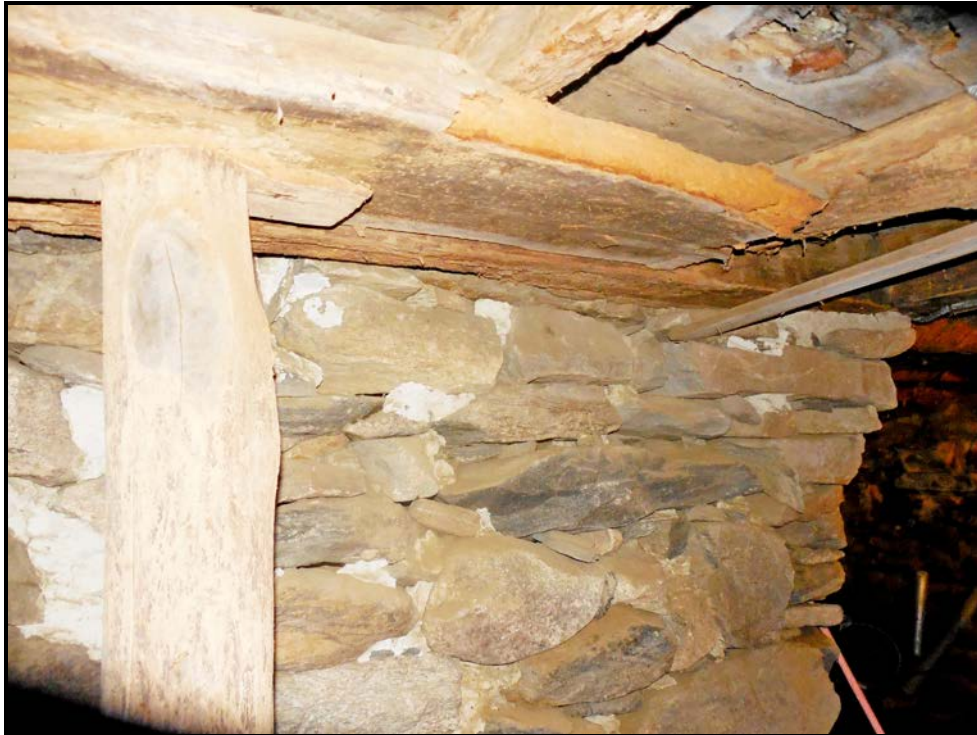
**Photo P03 – Timber joists and beams with powder post beetle damage. Note temporary shoring.**

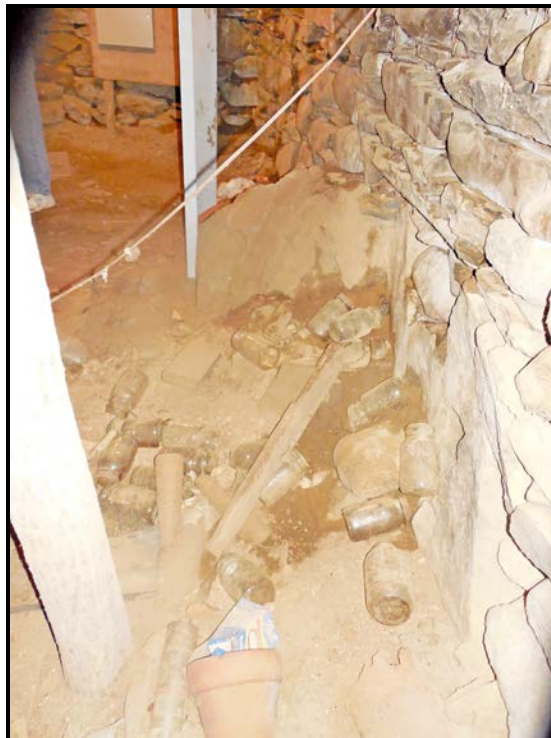
**Photo P04 – Stone foundation wall with soil wash out accumulation.**

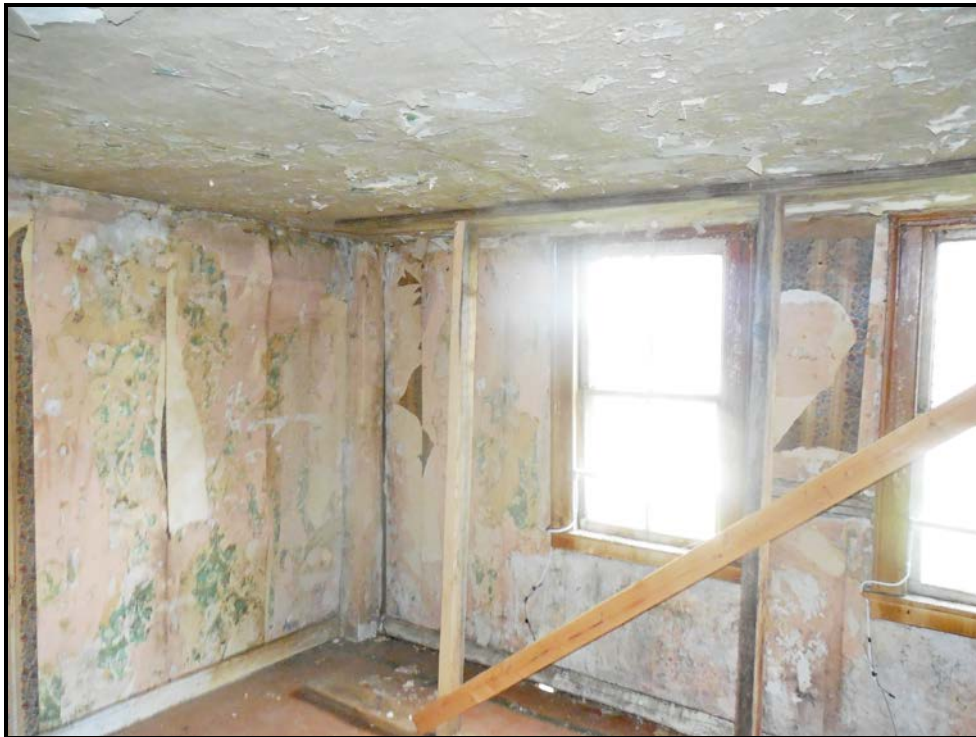
**Photo P05 – Front parlor (at south east corner) with sill/wall planking base damage and movements**

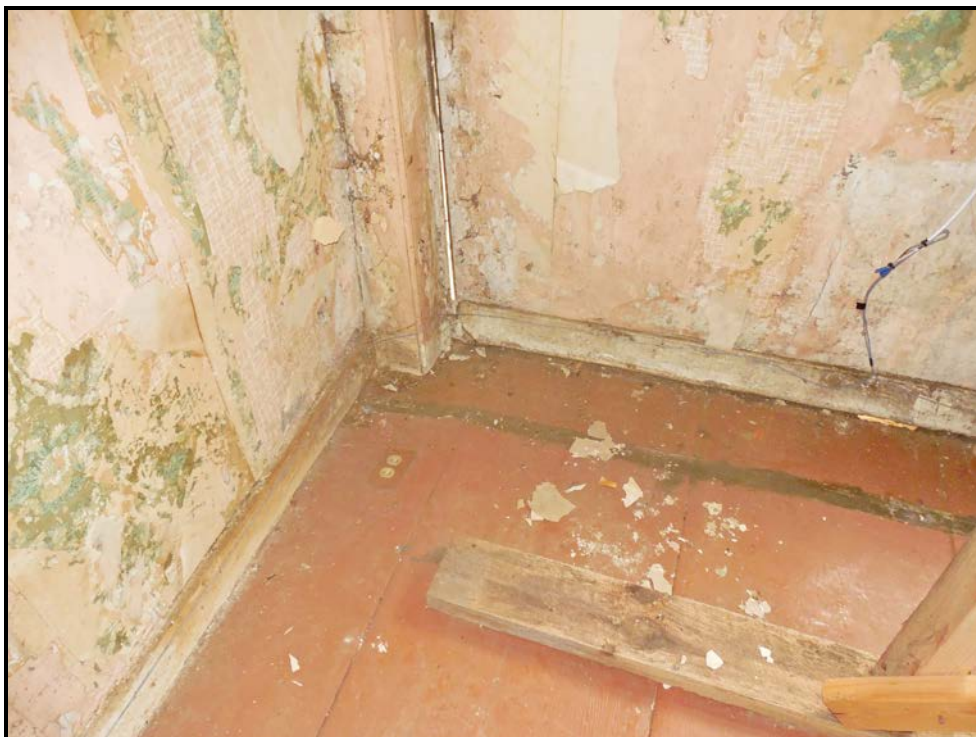
**Photo P06 – Close up of damage at front parlor southeast corner. Note lateral movement at floor and light entry at post.**

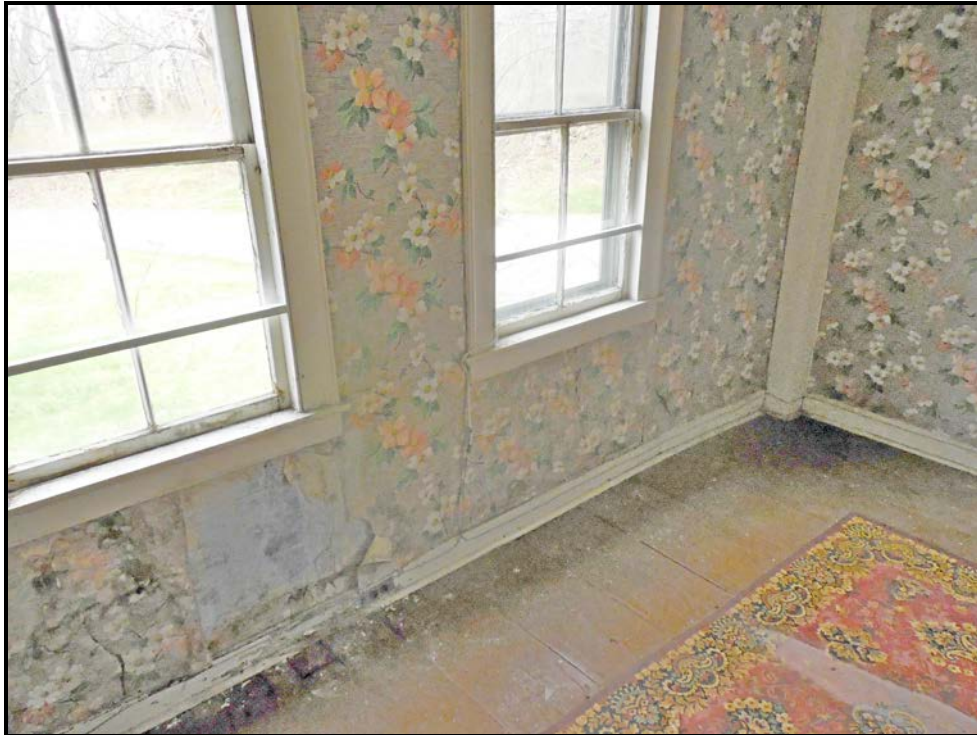
**Photo P07 – Moisture/damage at sill line in southwest parlor front wall.**

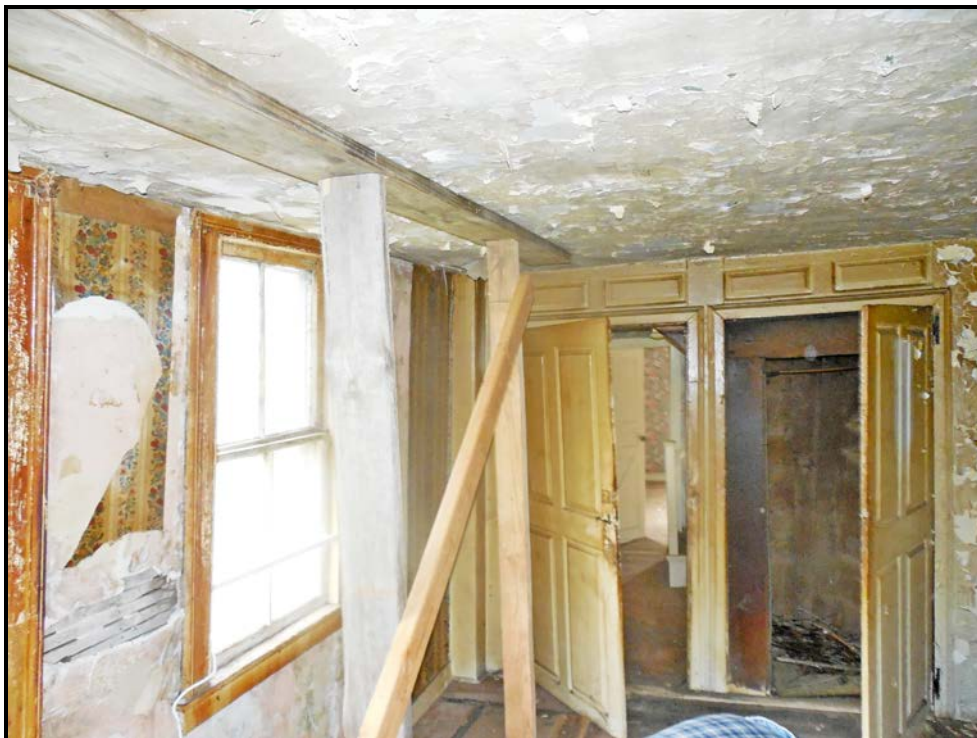
**Photo P08 – Shoring of 2<sup>nd</sup> floor joists at south/front wall.**

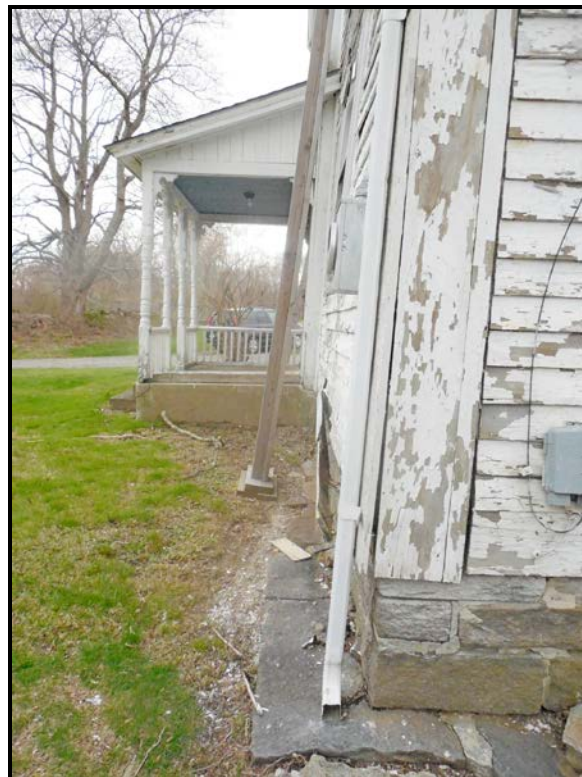
**Photo P10 – Front sill/post damage and outward movement of wall base at southeast corner.**

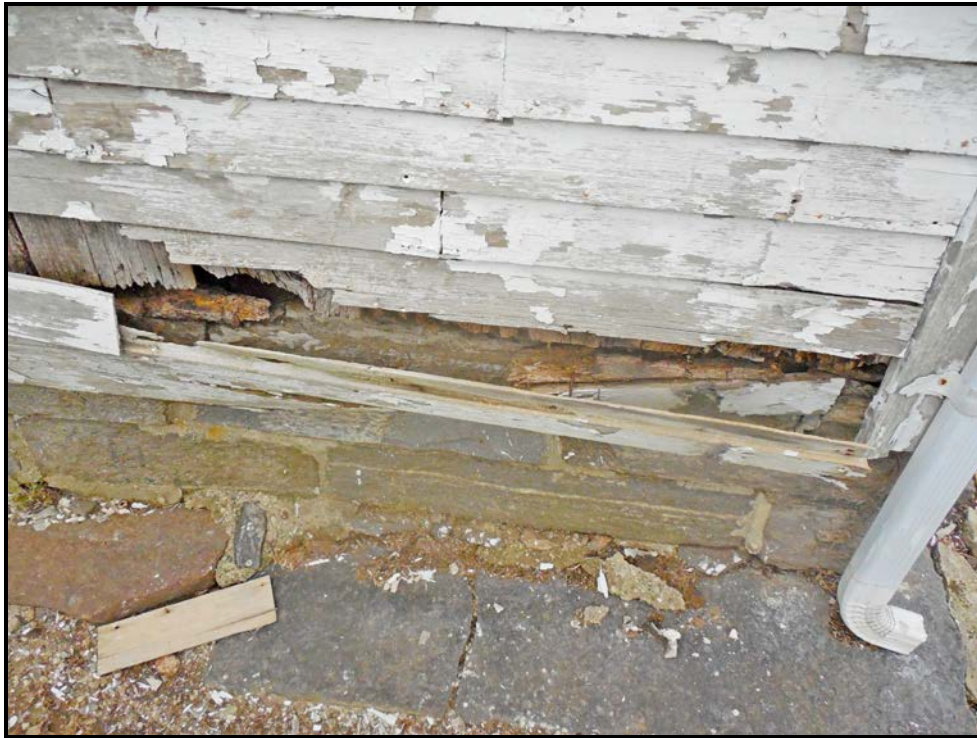
**Photo P11 – Close up of southeast corner sill and post water damage.**

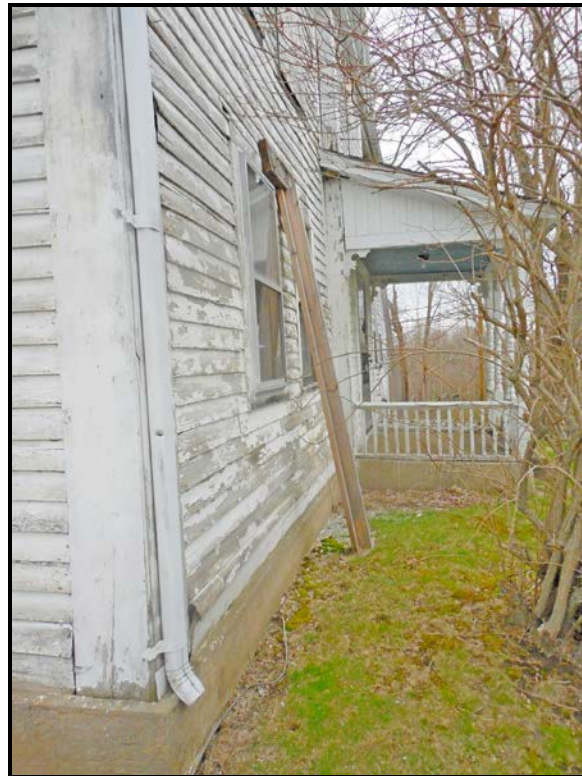
**Photo P12 – Front wall at west side with modern concrete encapsulation base trapping moisture.**
