Lisbon Water Pollution Control Authority
Special Meeting
March 14, 2019, 7:00pm
Lisbon Town Hall

Re: System-wide Grease Trap Inspections &
WPCA Regulation Update
TEI Job #09-069

Lisbon WPCA Running Grease Trap Inspection Notes Updated: March 1, 2019

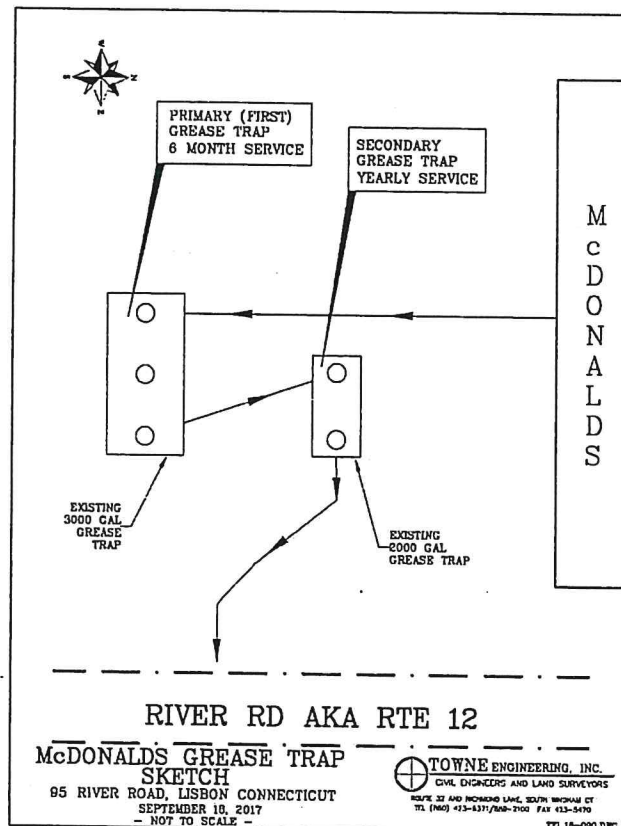
- **March 1, 2019**
 - Primary tank (3000 gallon) had about 8" of chunky floating grease.
 - Secondary tank (2000 gallon) have a minimal about of floating grease

- We contacted Baker Commodities regarding primary tank service due early March
 - Service of primary tank is scheduled for Thursday March 7th at 7 am.

- **May 8, 2018**
 - Restaurant has been re-opened following remodeling
 - Observed 2" of floating grease in southerly tank, tank was warmer than recalled from previous inspections and the grease was very loose.

- Observed 4 to 6 inches of chunky grease in northerly tank. We were not able to access the outlet to the northerly tank due to a car being parked on the cover.
