TEST REPORT

REPORT NUMBER: 3154174SAT-001
ORIGINAL ISSUE DATE: July 25, 2008
REVISED DATE: N/A

PRODUCT EVALUATED: White Fireshell intumescent coating over 4 ½ inches
of 2 pcf spray foam insulation
EVALUATION PROPERTY: Heat Release, Flame Spread

**Report of testing white Fireshell intumescent coating for
compliance with the applicable requirements of the following
criteria: NFPA 286 and IBC 803.2.1.**

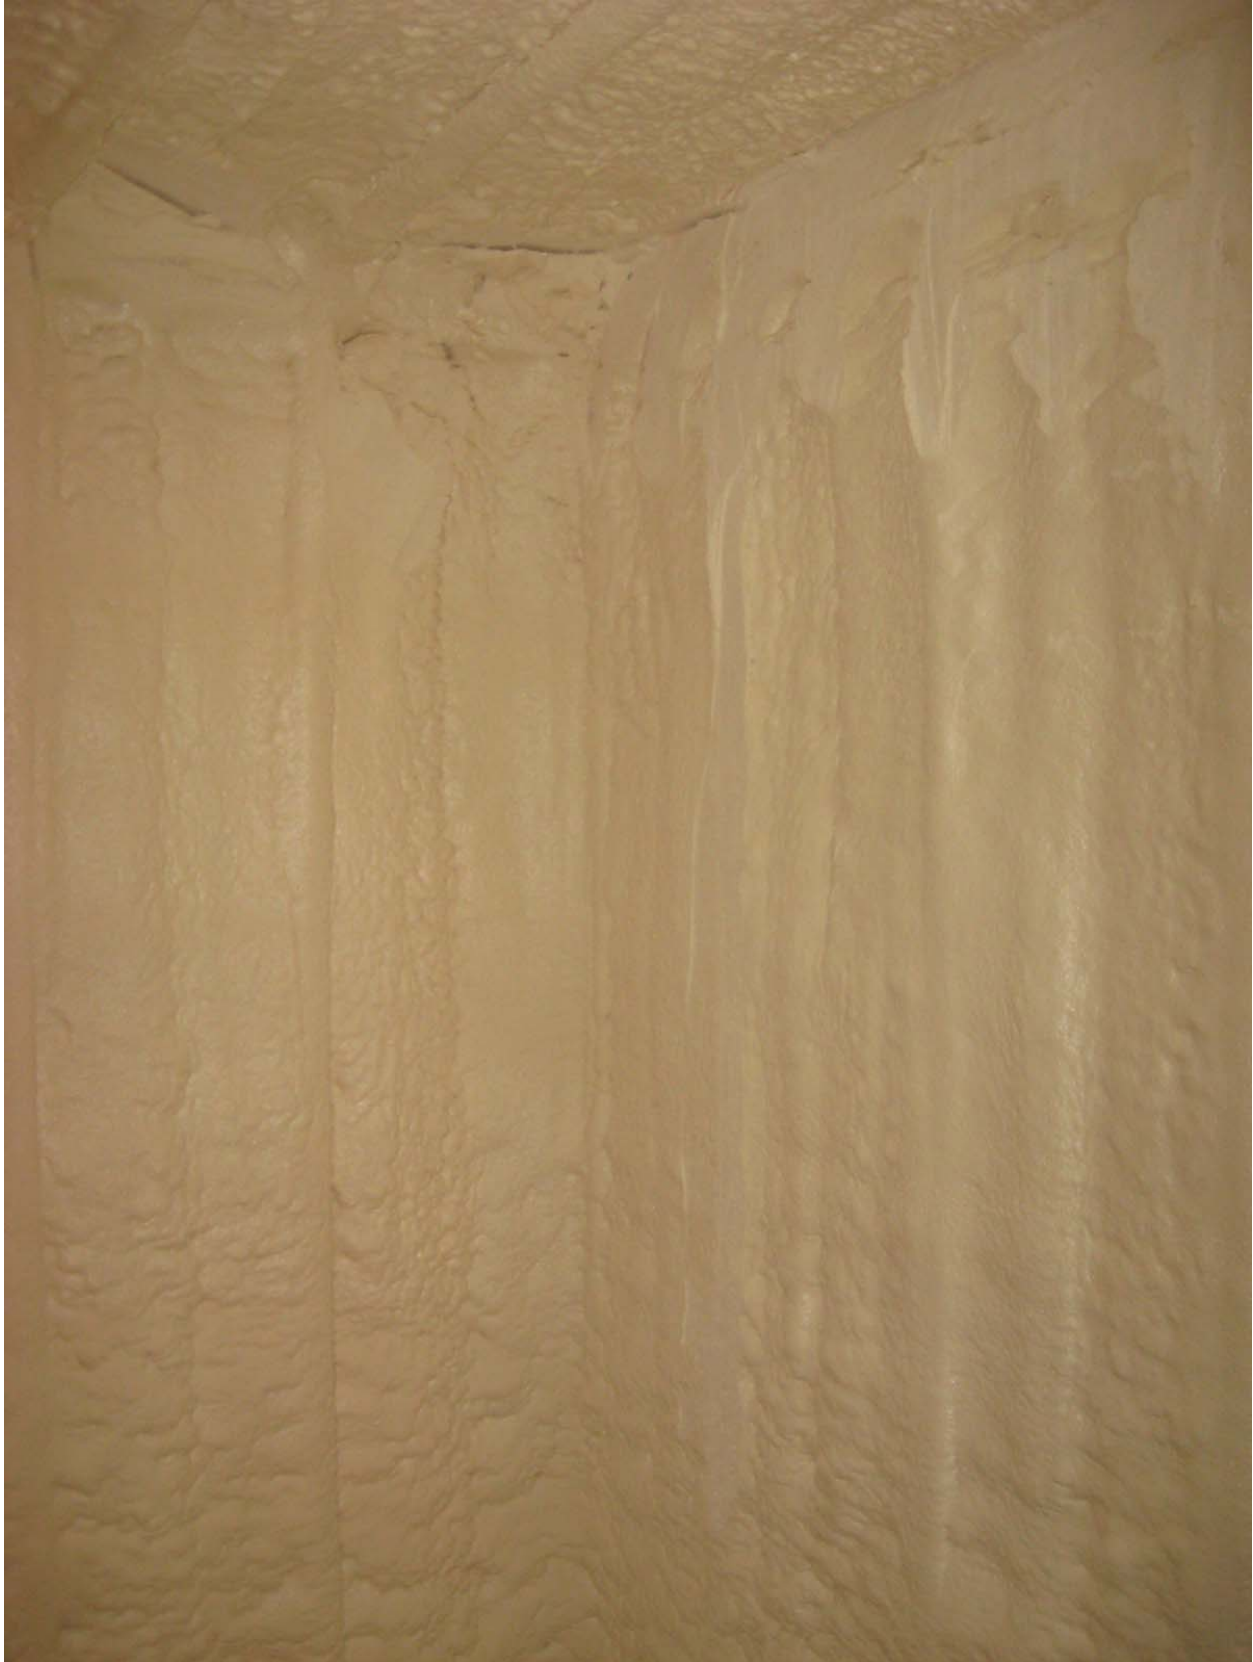
Pre-test photo of bare foam

On top of this substrate, an unidentified 2 pound per cubic foot spray foam was applied to a thickness of a nominal 4 ½ inches. The Fireshell intumescent was applied to a dry thickness of 0.016 inches.

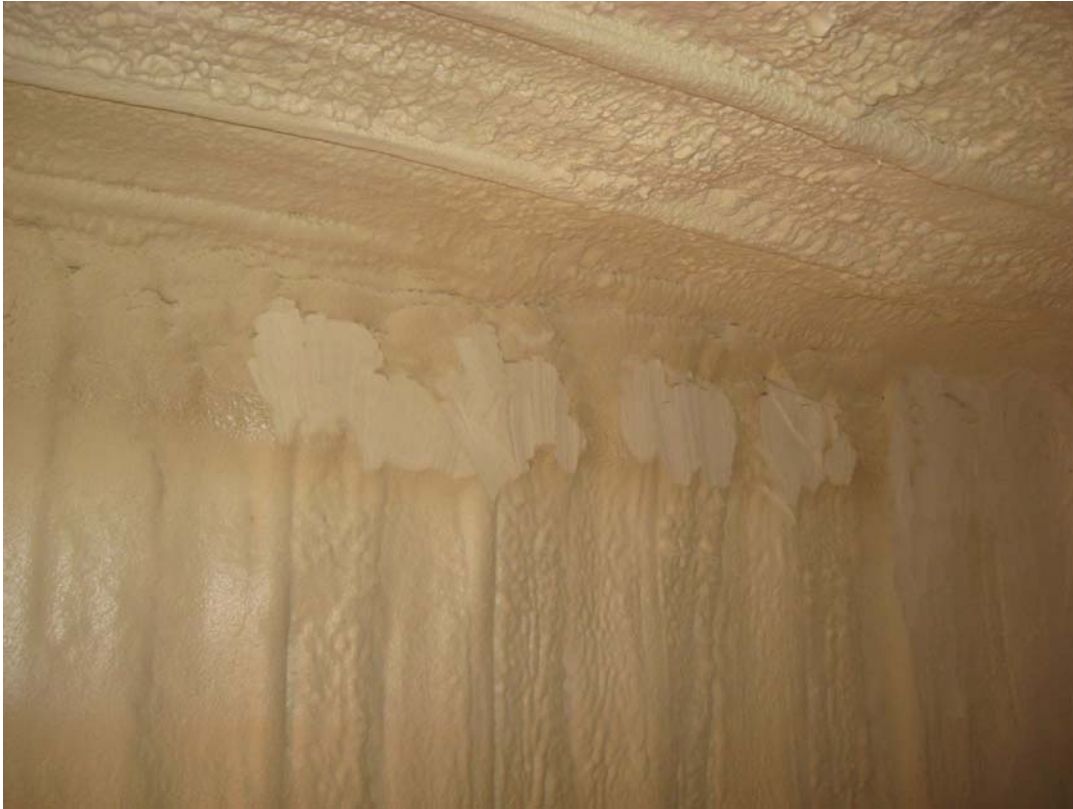
Foam trimming

Samples were submitted to Intertek directly from the client. The spray foam was applied on June 13, 2008, and trimmed on June 23 and 24, 2008.

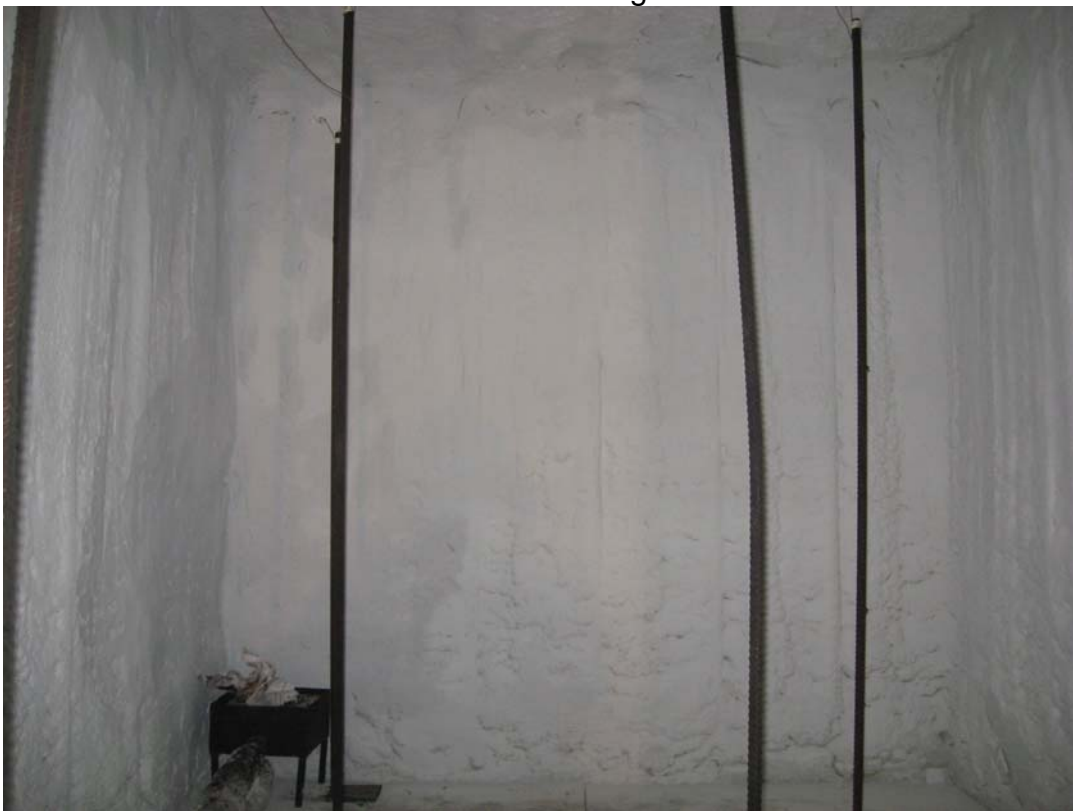
Pre-test photo back wall

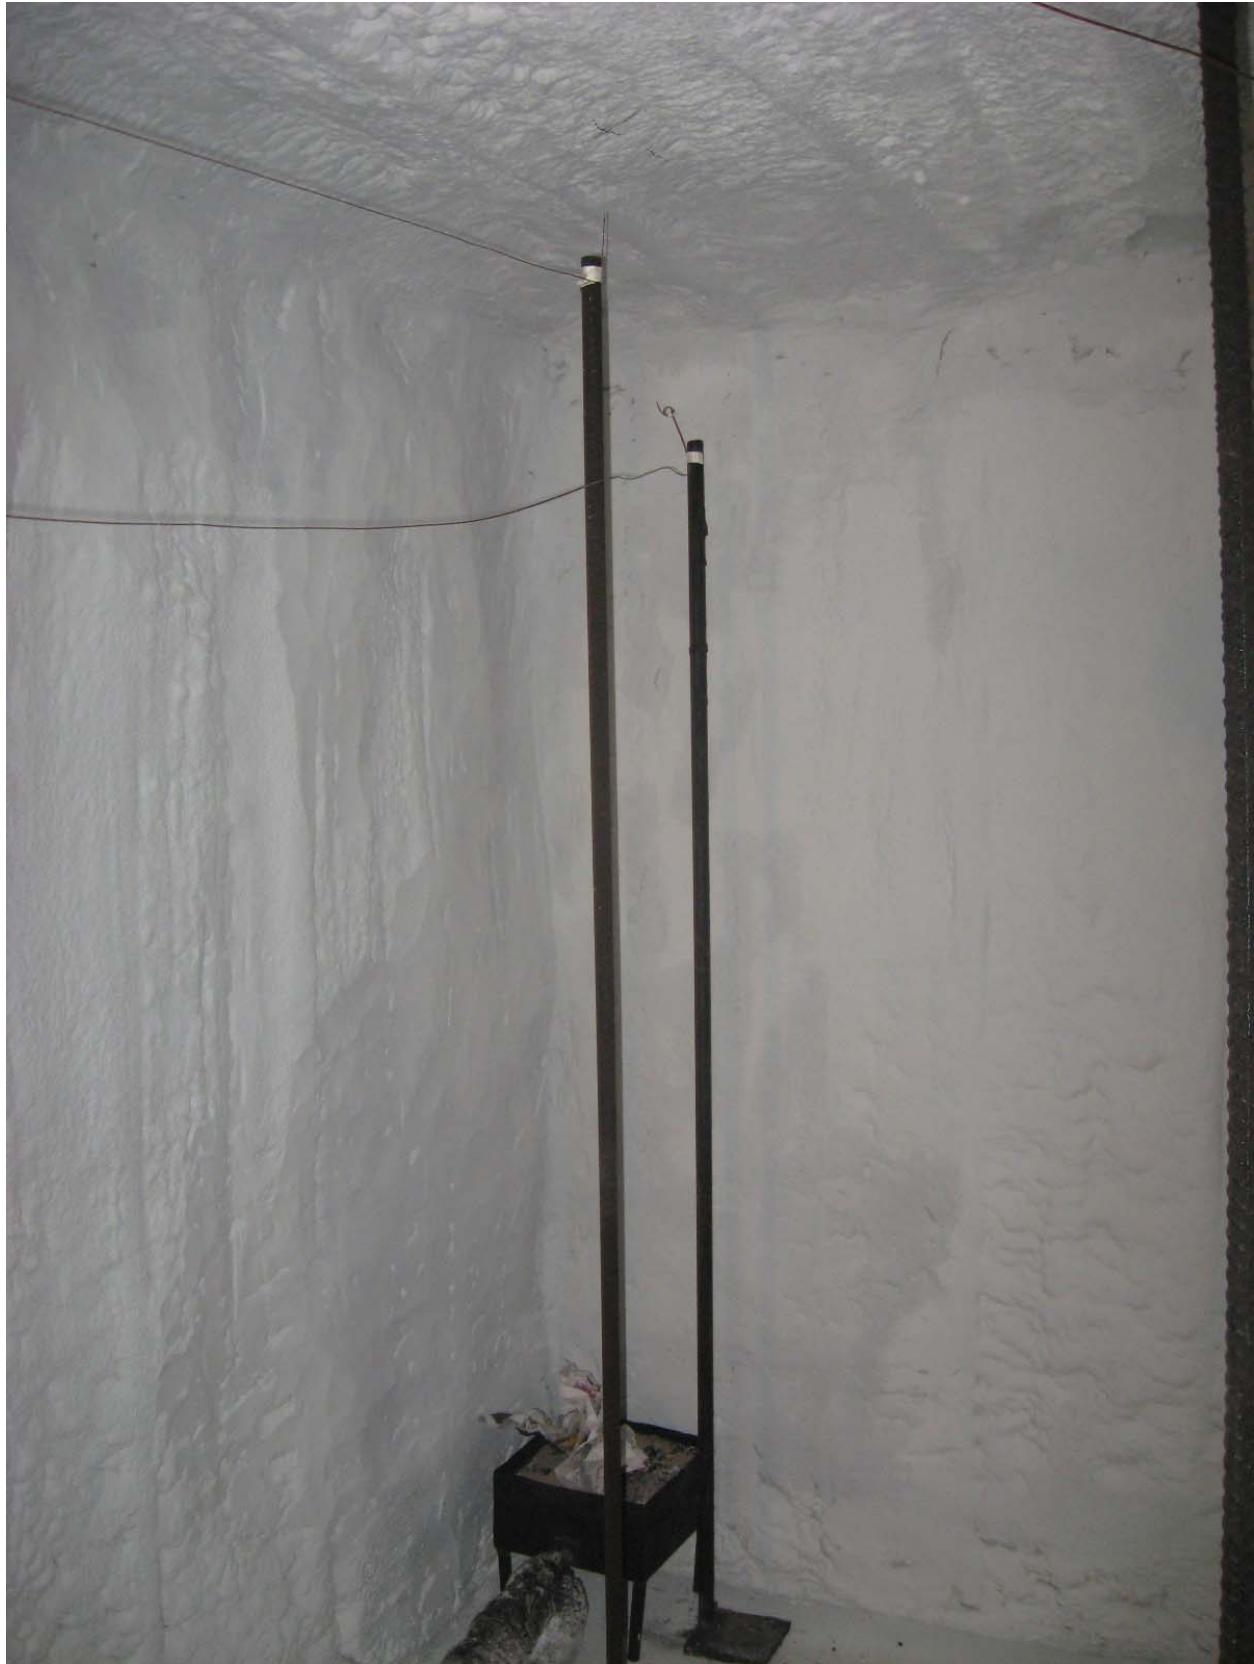
Pre-test photo corner

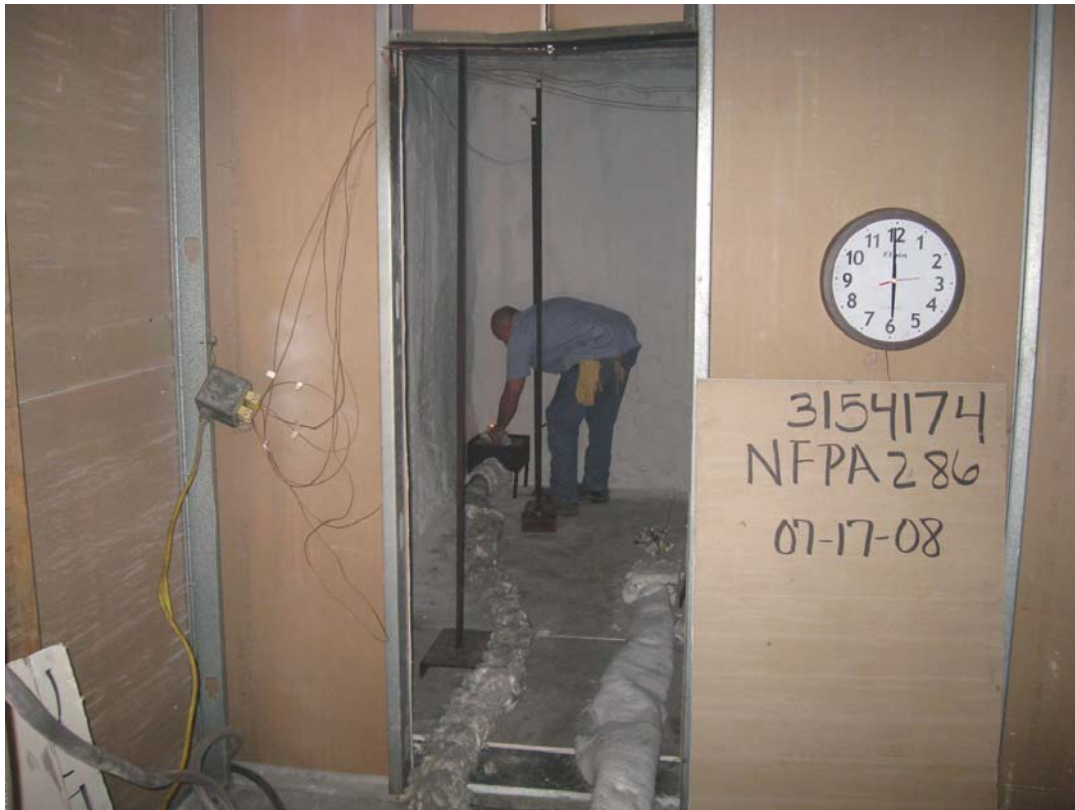
Start of test. 40kW

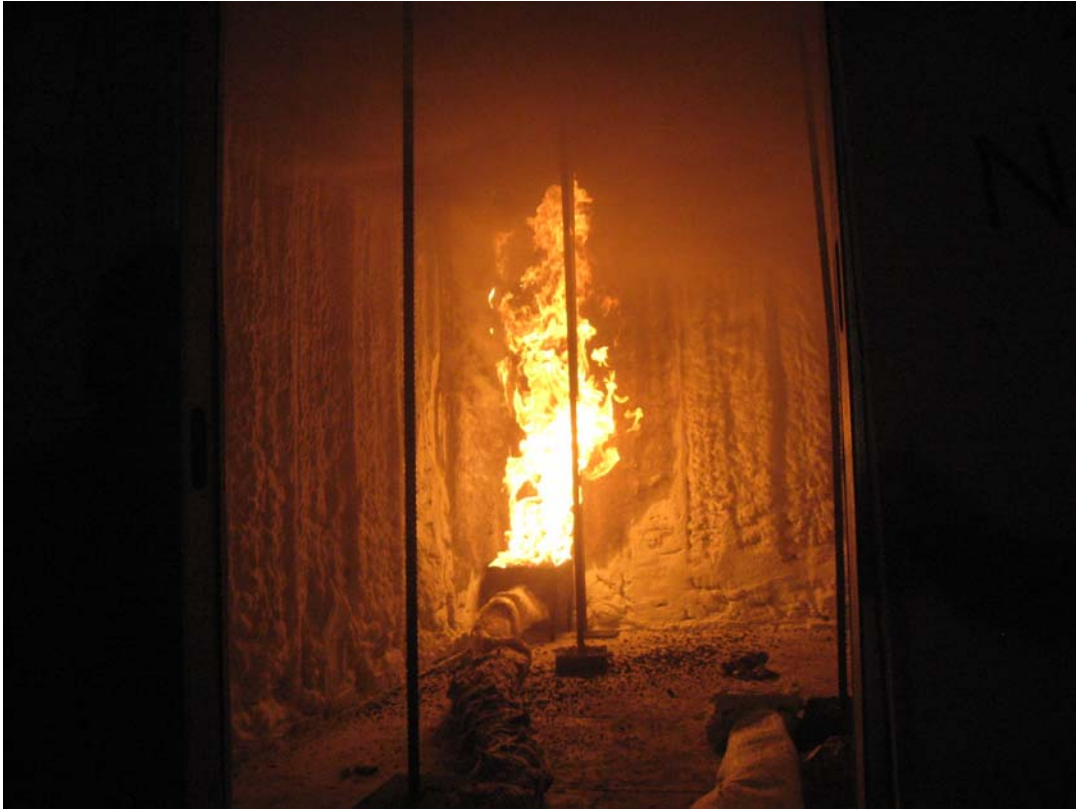
Spreading discoloration

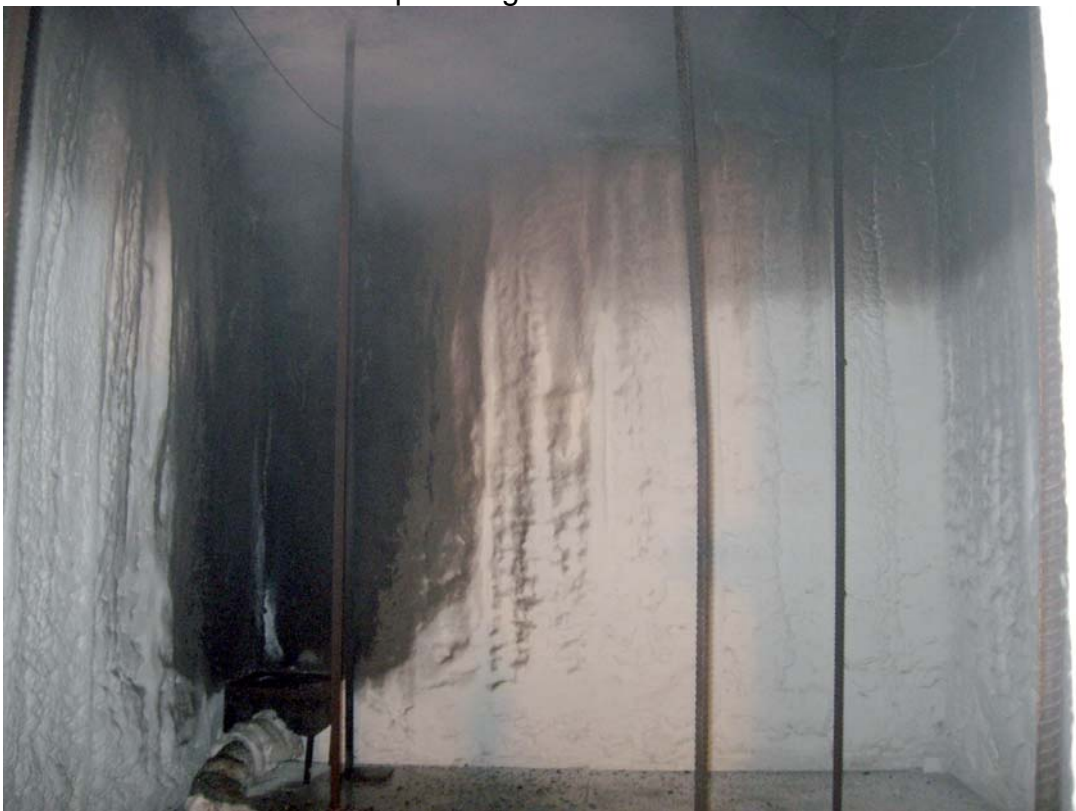
Post-Test photo

The intumescent and foam were heavily charred and cracked in the area immediately surrounding the burner flame. The charred area spread as it reached the ceiling. The extremities did not show signs of combustion. The paper targets did not ignite.
